Corrosion analysis of modern and historic railway track with optical, electron and correlative Raman microscopy

Authors: Dr. Roger Barnett
Carl Zeiss Microscopy Ltd.

Date: December 2019

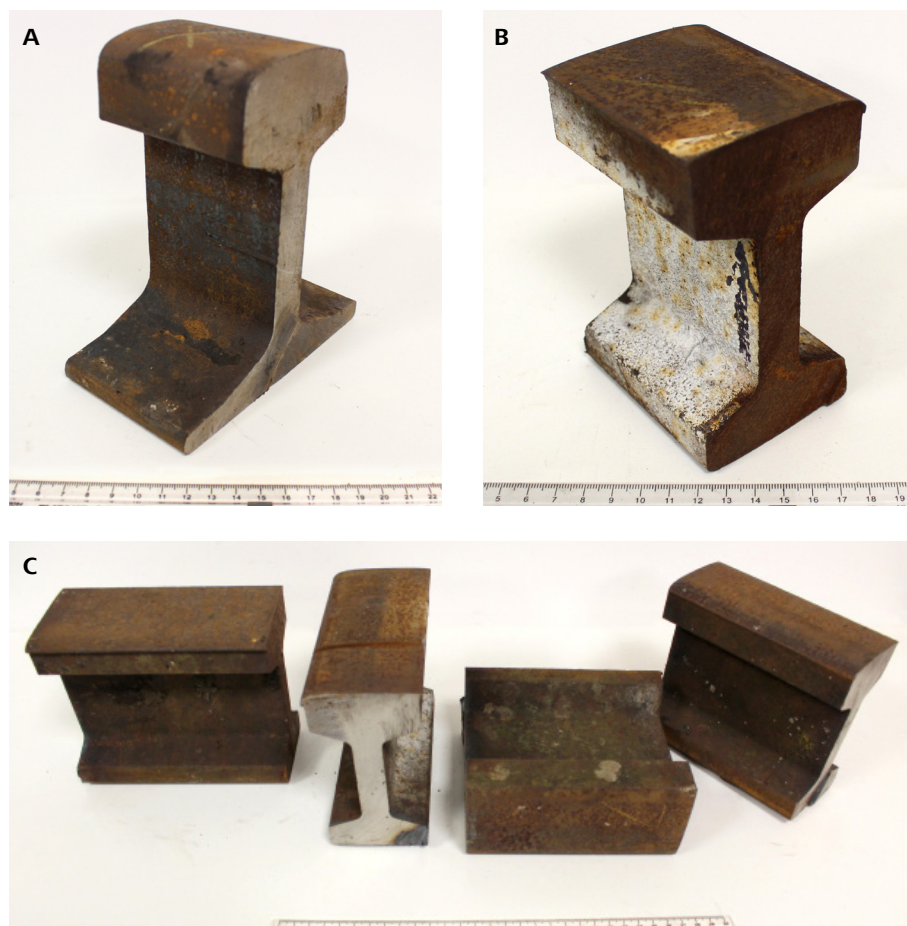
Sample A (2017 rail, unused) appears relatively intact, with no visible deformation, but with corrosion of the outer surface. For Samples B and C (1940s-1950s and 1928-1932 rail respectively, both used), removal of material on the top surface was apparent, with deformation visible on the inside corners of the rail. Corrosion and associated corrosion scale were visible on all surfaces; the white layer on the exterior of B and some of C was believed to be a paint or other coating.

Figure 1 Railway track samples, courtesy of Nene Valley Heritage Railway – A) 113A non-prime rail, 2017, unused; B) 95 lb bullhead rail, 1940s-1950s, used; C) 85 lb bullhead rail, 1928-1932, unused

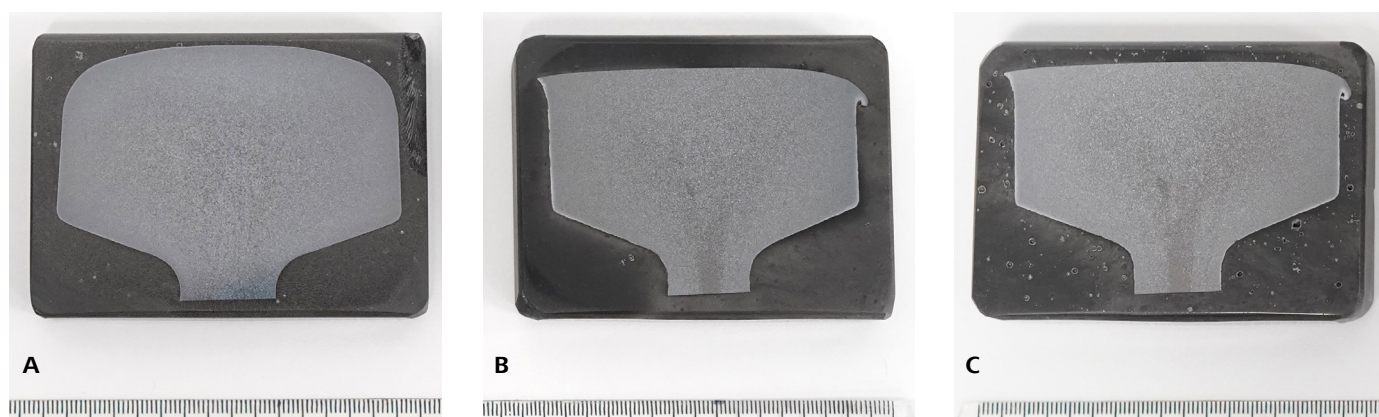
For both Sample B and Sample C, damage is clearly visible, with the right side of the rail deformed and folded over onto itself, while the left side had a corresponding protrusion.

The cores of Samples B and C also show a clearly different microstructure to the exterior. The same effect can be seen in Sample A but is less pronounced.

Figure 2 Large cross-sections of the heads of rail track samples – A (2017), B (1940s-1950s) and C (1928-1932) respectively. Samples courtesy of Nene Valley Heritage Railway

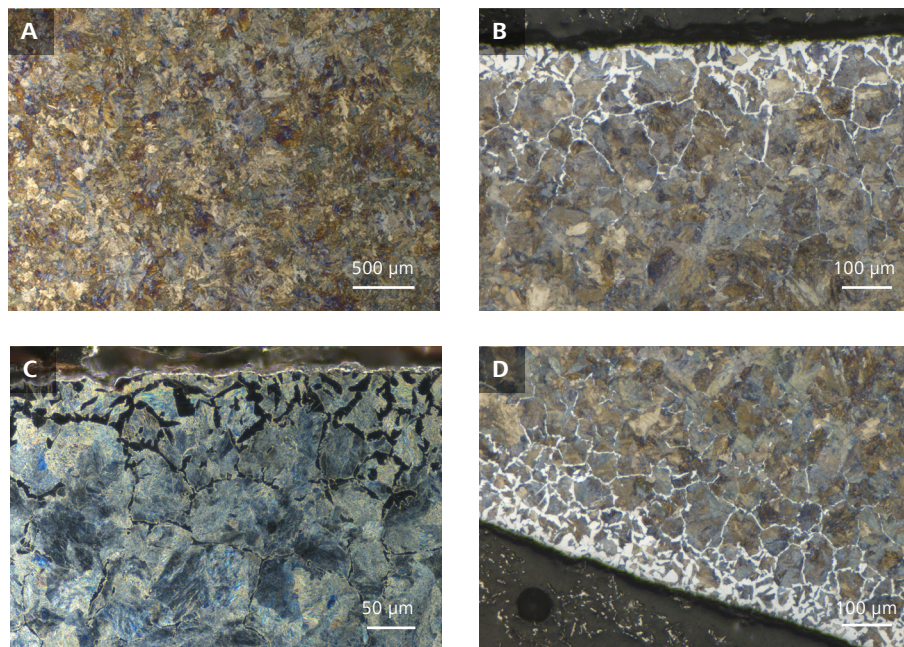
Figure 3 shows that Sample A (2017) was primarily a pearlitic-martensitic steel. Examination of the near-surface regions on the underside of the head (where little or no wear should have occurred) showed the presence of white regions (in brightfield) along the grain boundaries – likely decarburization to a depth of 300-400 μm . A similar microstructure was present on the head of the on the head of the steel. Due to the lack of wear, this verified the rail had seen little or no use. Darkfield imaging highlighted these areas even more clearly, illustrating the value of multiple contrast modes in an examination by light microscopy. No significant non-metallic inclusions were visible, though this can be obscured by etching. Patchy and thin corrosion scale was present on the uppermost surface.

Figure 3 Microstructure of Sample A (2017) – A) Center of the head, brightfield; B) Top of the head, brightfield; C) Top of the head, darkfield; D) Underside of the head, brightfield. Sample courtesy of Nene Valley Heritage Railway.

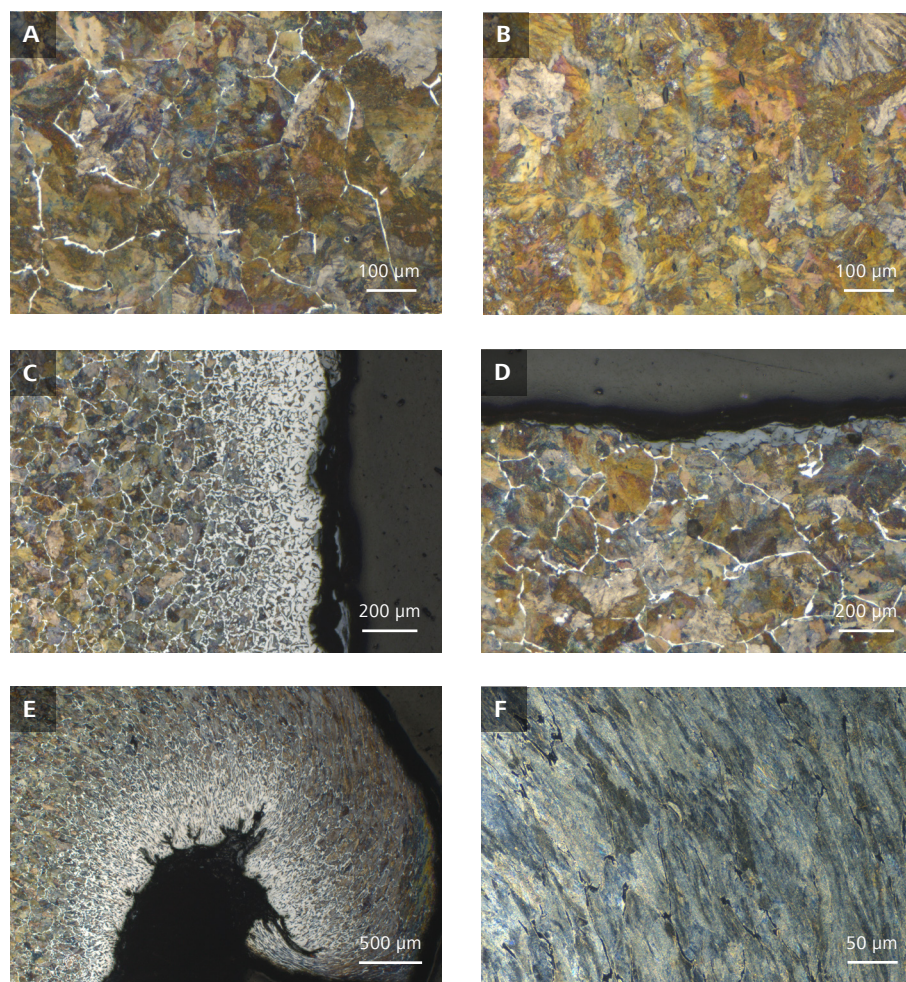
The microstructure of Sample B (1940s-50s), Figure 4, was substantially different. While still pearlitic there was some evidence of grain boundary segregation in the middle of the head. This is not present in the middle of the strut. The grain size was larger than that in the newer railway track (Sample A), indicative of different heat treatment and processing.

Several large non-metallic inclusions are visible in the both the head and the strut. In the strut, the sulfide inclusions are elongated in the vertical direction, due to the forging process. While these inclusions are also probably heavily elongated in the rolling direction, the cross-sections are taken perpendicular to the rolling direction and, as such, this elongation is not visible. This provides strong evidence for the age of the steel: while non-metallic inclusions are common to all steels, advances in steelmaking over the past 60 years have steadily reduced both the number and size of non-metallic inclusions typically found in steel. This high number of large inclusions is typical of an older grade.

The side of the strut shows heavy levels of decarburization, up to 620 μm deep. This is greater than Sample A (2017) and is indicative of a different steel composition and a different heat treatment/forging process. No decarburization was visible on the top surface: the microstructure here is almost identical to that in the middle of the head. It can be confirmed that a minimum of 600 μm of material wore away during service but considering the heavy damage on the right side, the damage was likely significantly deeper. Deformation and elongation of grains is visible in this area with cracking on the underside of the material. The whiter post-etching microstructure on the underside of the damaged region is likely due to the decarburized region remaining in place (though heavily deformed), local strain, and grain elongation.

Corrosion scale was visible on the upper surface and on the sides of the strut. In both cases, this was thicker than that observed on Sample A (2017). This scale was patchy, indicating it was not adherent or protective. This is typical of a standard oxide scale on steel.

Figure 4 Microstructure of Sample B (1940s-50s) – A) Center of head, brightfield; B) Center of strut, brightfield; C) Side of strut, brightfield; D) Top of head, brightfield; E) Damage to the rail on the right side, low magnification, brightfield; F) High magnification darkfield image of the damage.

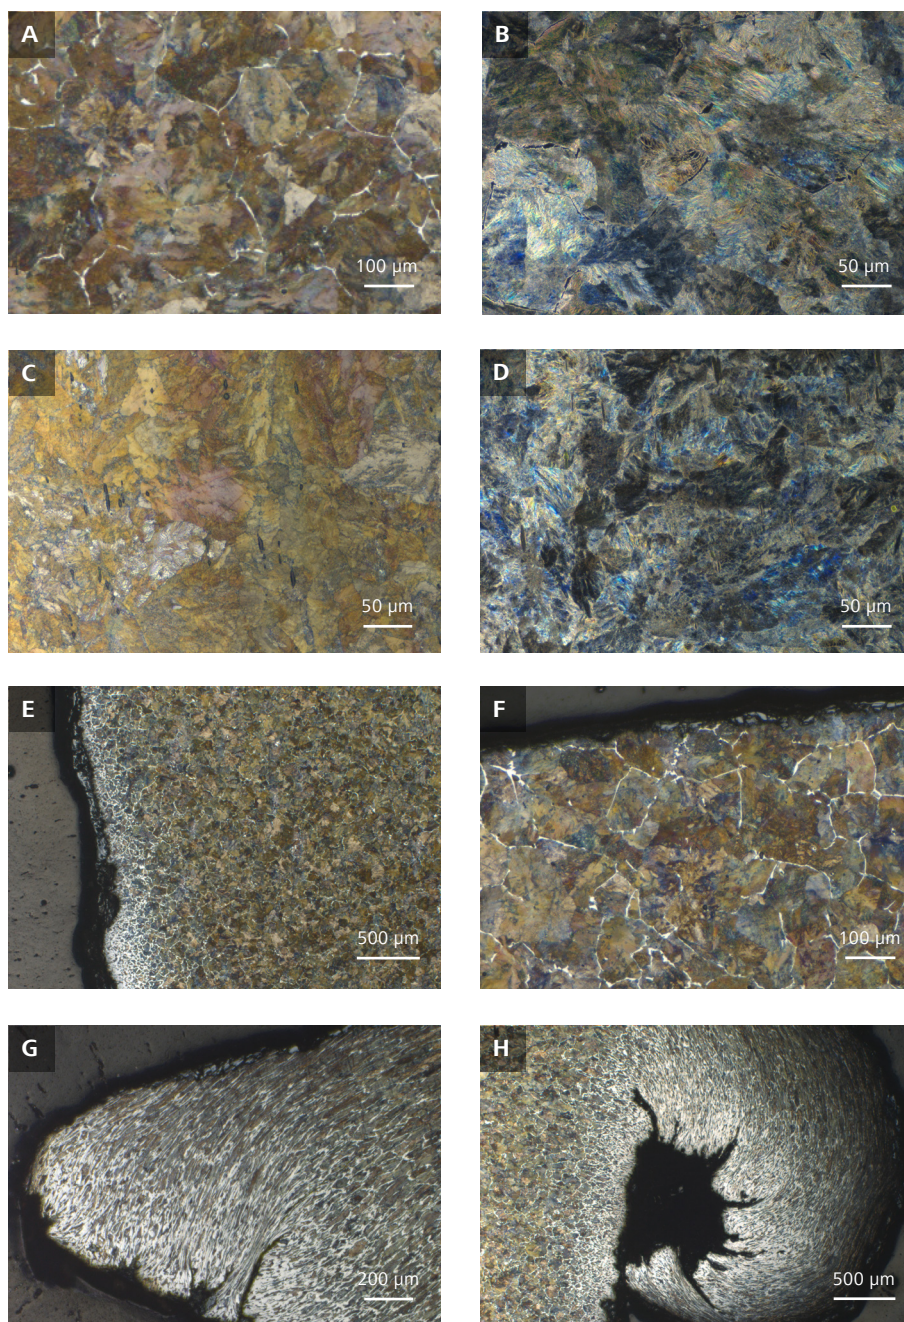
Examining Sample C (1928-1932) confirms that the microstructure mid-head and mid-shaft is very similar to that observed in Sample B (1940s-50s), Figure 5. Segregation at the grain boundaries was present in the head only and the grains were larger than in Sample A (2017). There were high levels of non-metallic inclusions and decarburization on the side of the strut to a depth of approximately 600 μm . The top surface of the head showed identical microstructure to the middle of the head; any decarburized layer had long since been worn away. Corrosion scale was present on the surface.

The damage on the left side and right side of the head was more severe than in Sample B, with a greater volume of material bent over to a sharper angle. This was potentially indicative of greater length of service, or poorer resistance to deformation. Again, cracking was observed on the underside of the damaged curl, and the same grain elongation and preservation of some decarburized layer. Overall, the appearance of this rail was similar to that of Sample B (1940s-50s).

Figure 5 Microstructure of Sample C (1928-1932) – A-B) Center of head, brightfield and darkfield; C-D) Center of strut, brightfield and darkfield; E) Side of strut, brightfield; F) Top of head, brightfield; G) Damage to the left side, brightfield; H) Damage to the right side, brightfield.

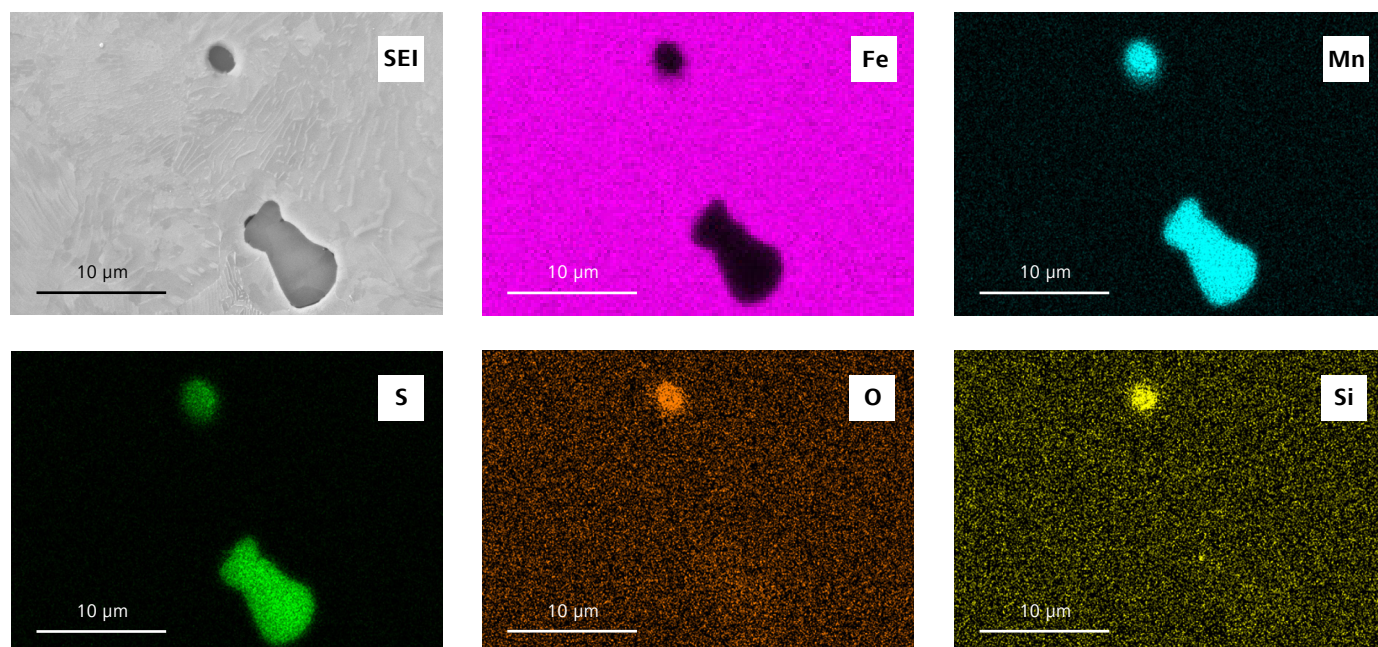
Example inclusions are shown in Figure 6. The structure is clearly pearlitic with visible cementite lamellae. The larger inclusion does not contain any oxygen and is primarily comprised of Mn and S, indicating it is a classic manganese sulfide inclusion. The smaller inclusion is primarily silicon oxide. X-rays emitted from this area also correspond to Mn and S (though weaker), indicating that this oxide inclusion may have a sulfide shell or there may be a sulfide inclusion below the oxide within the electron beam interaction volume.

Figure 6 Secondary electron image and EDS map of inclusions in Sample B (1940s-50s). Sample courtesy of Nene Valley Heritage Railway.

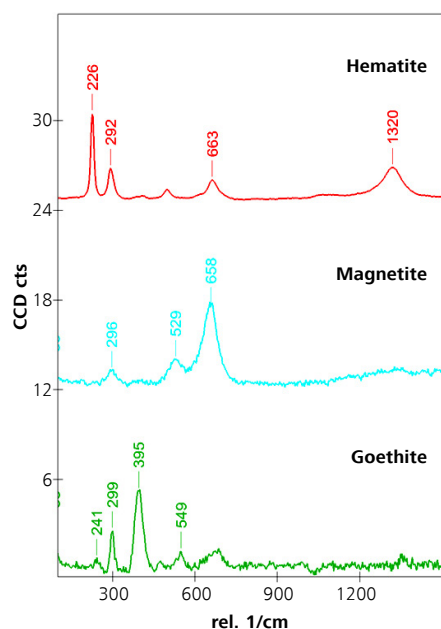
Figure 7 Raman spectra of all the major constituents of corrosion scale on Samples A and B.

RRUFF database of Raman spectra, the scale constituents were identified as the iron oxides hematite Fe_2O_3 , magnetite Fe_3O_4 , and the iron oxyhydroxide goethite $\text{FeO}(\text{OH})$. The spectra are shown in Figure 7. The steel is metallic and therefore does not generate a relevant Raman spectrum.

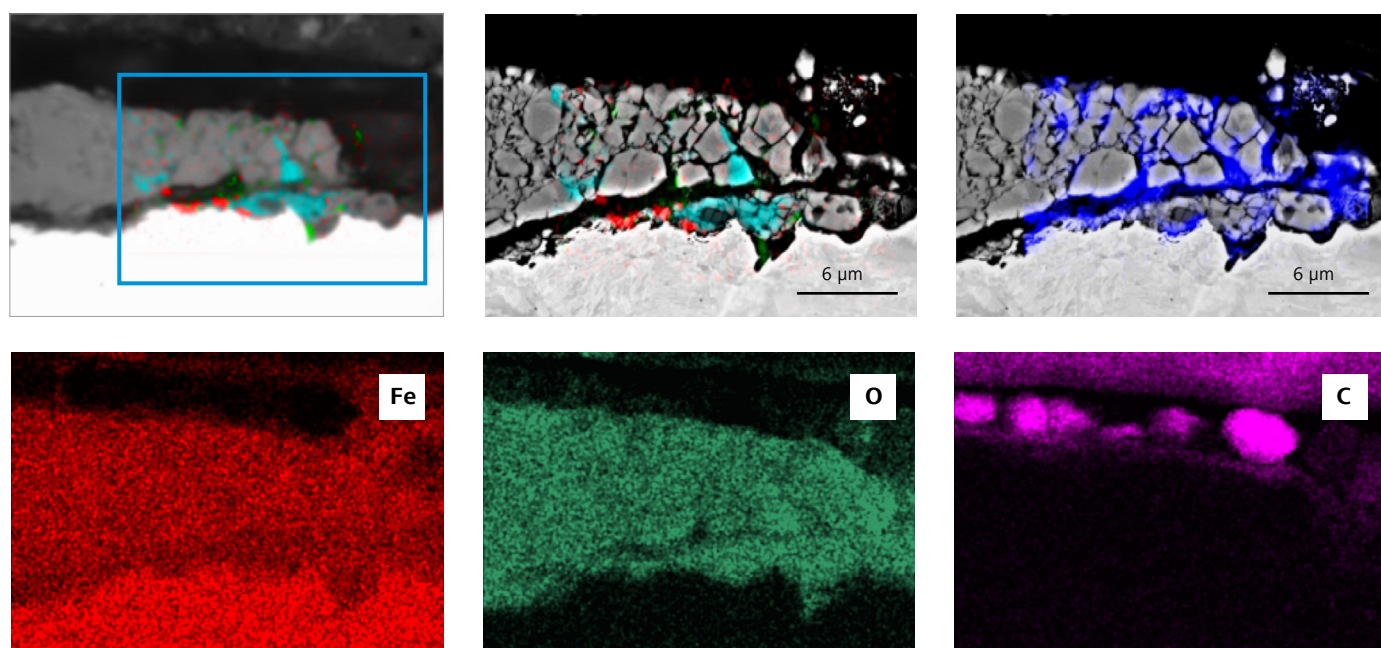
Combining both Raman data and EDS data, it was possible to get a better overall picture of the corrosion of each material. For Sample A (Figure 8), the corrosion scale on the head was primarily not sub-surface and consisted principally of goethite and magnetite, with some hematite. There was no correlation between distance from the steel and the scale formed, save that there was more goethite than hematite and magnetite. These iron compounds were only differentiable by Raman spectroscopy, due to the very similar levels of oxygen in the corrosion scale and the interaction volume of the electron beam.

Figure 8 Raman maps of corrosion scale on Sample A (2017), overlaid onto light micrograph and scanning electron micrograph. Red = hematite, Light blue = magnetite, green = goethite. An overlaid map of carbon distribution (dark blue) is also provided. EDS spectra of this region are shown. Sample courtesy of Nene Valley Heritage Railway.

The scale was porous, as evidenced by high levels of carbon between parts of the scale, corresponding to metallographic mounting resin. This corrosion is likely a function of exposure of the fine-grained decarburized surface to the general atmosphere with intermittent wetting (weather).

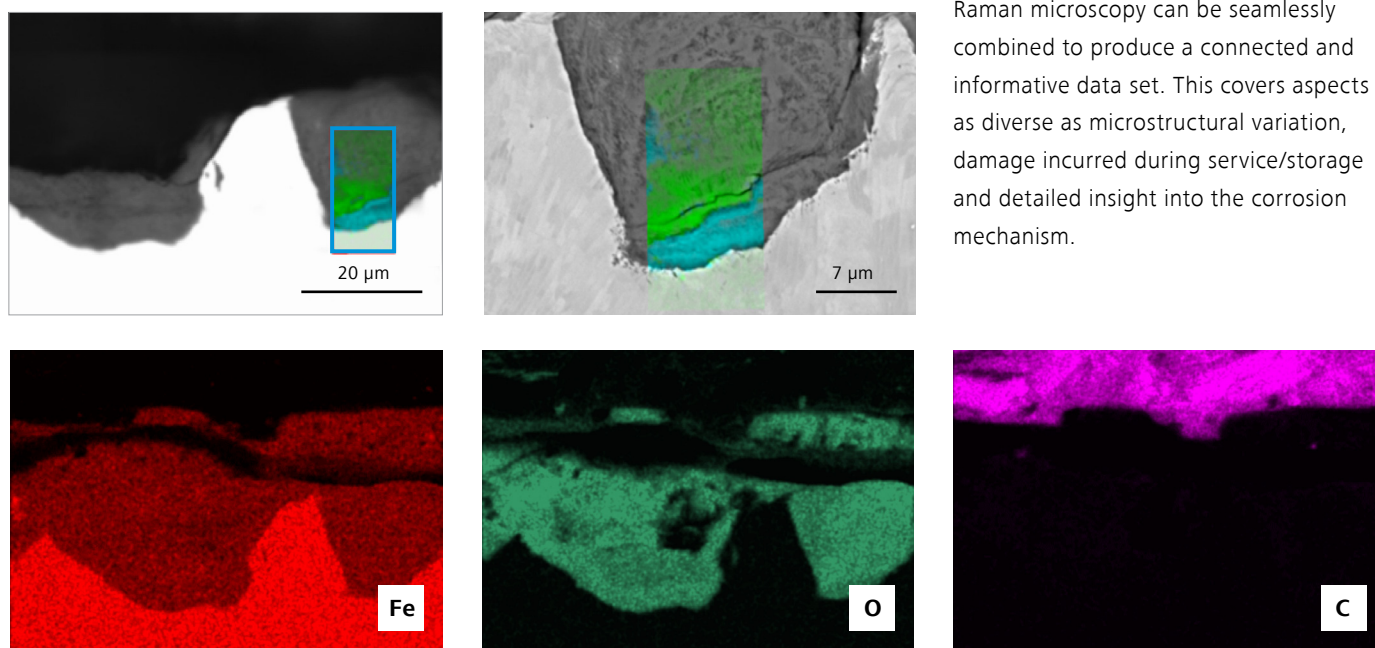
For Sample B (1940s-50s), the corrosion behavior was completely different, Figure 9. No hematite was observed sub-surface, the scale consisted of magnetite close to the surface of the head and goethite further away. This gradient is a function of oxygen diffusion through the scale with magnetite (forming in a lower oxygen environment (with a lower

oxidation state of iron). The hydrated oxide goethite is again a function of exposure to the general atmosphere plus weather events. Once again, these oxides were not easily differentiable by EDS alone.

The scale was less porous but penetrated deeper below the substrate (up to 30 μm) likely due to the larger grains and non-decarburized structure in this region. This is completely different corrosion behavior to that observed in the 2017 trail track. The localized corrosion on the already-worn region forms regions which themselves are less resistant to further wear.

Figure 9 Raman maps of corrosion scale on Sample B (1940s-50s), overlaid onto light micrograph and scanning electron micrograph. Red = hematite, Light blue = magnetite, green = goethite. EDS spectra of the wider region are shown. Sample courtesy of Nene Valley Heritage Railway.
