Combined light-microscope – FIB/SEM failure analysis on automotive body parts

Technical Paper // Authors:

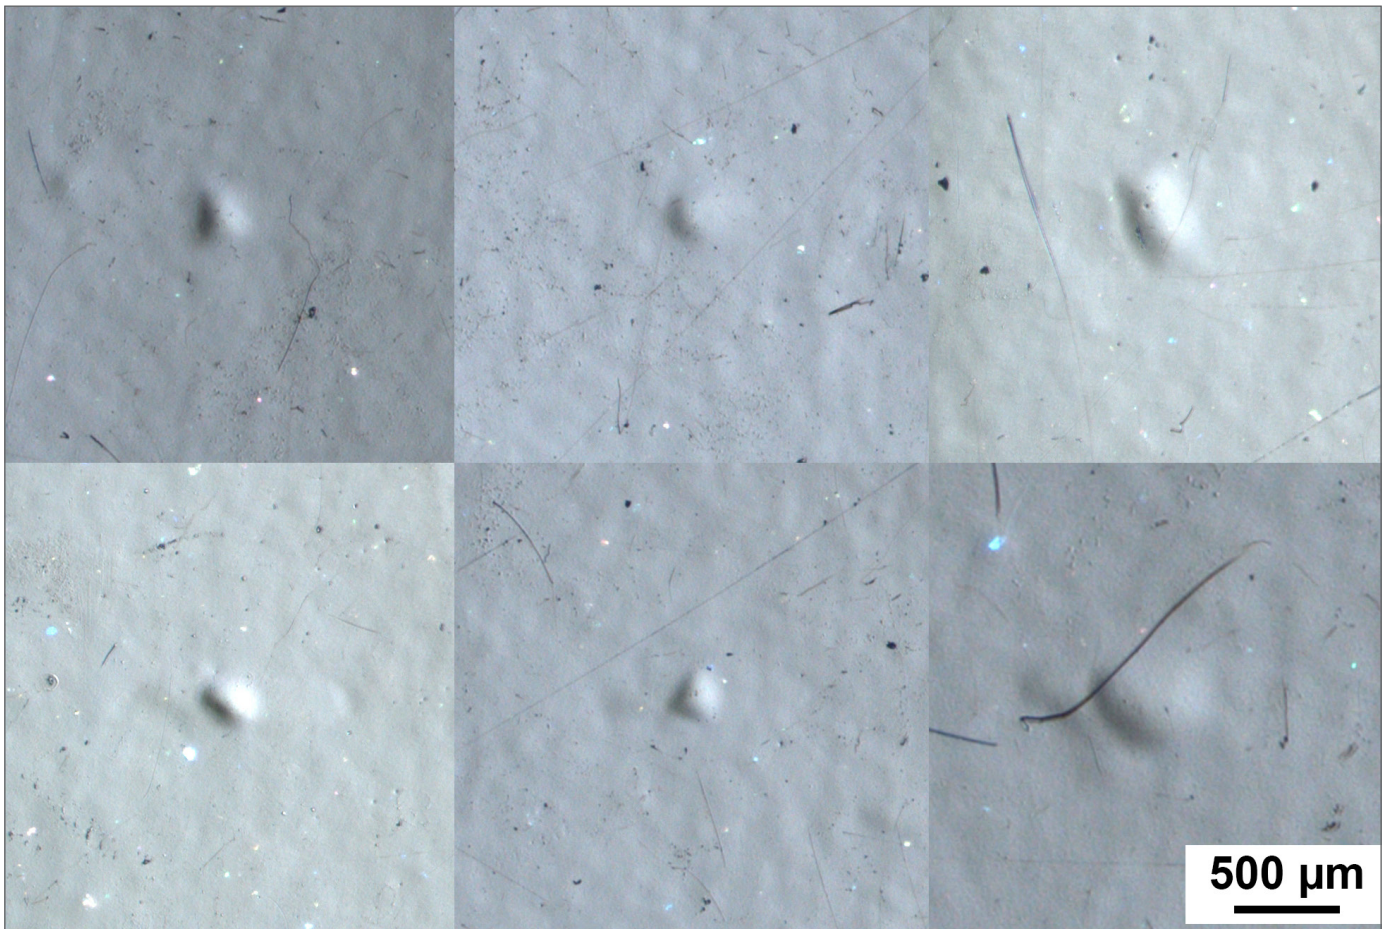
Figure 2: Set of different surface bulges found on the investigated part imaged with ZEISS Smartzoom 5.

Figure 2 shows a set of the found bulges on the painted surface after aging test with a diameter of approximate 100 μm . As ZEISS Smartzoom 5 is a fully integrated microscope, the precise location of every image on the sample is known to the software at any time. The whole set of acquired images was afterwards stored in the network accessible ZEN data storage to be re-loaded at the FIB/SEM.

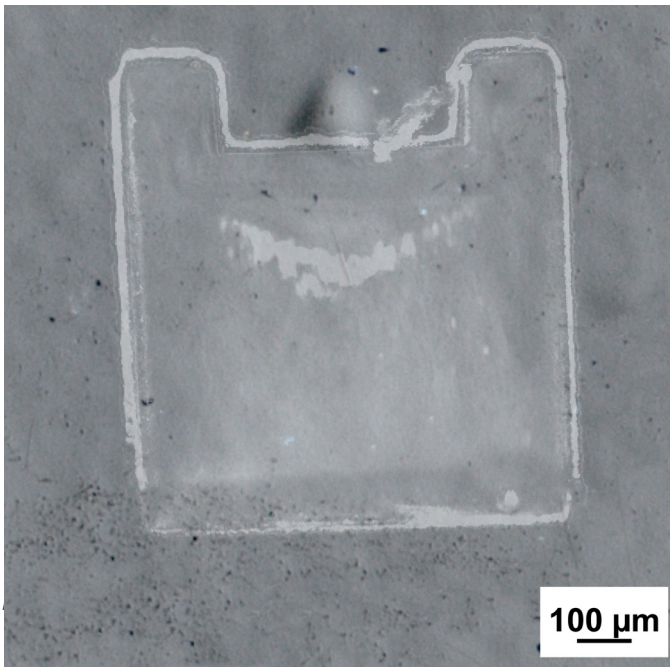
Figure 3: Overlay of laser-milled trench on lightmicroscope image of ROI.

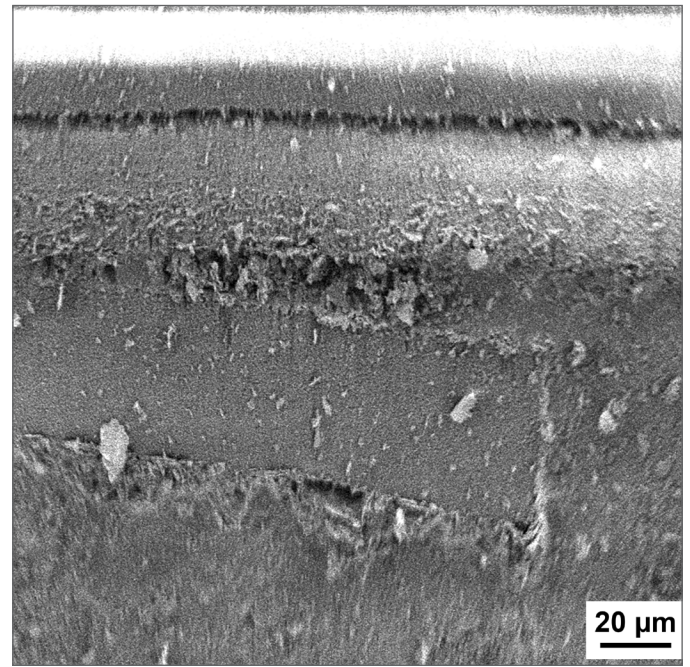
Figure 5: Suspicious feature in baser material underneath paint, laser-milled surface; SEM, SESI, 450x.

peculiarities, a closer inspection was carried out. Figure 5 shows the suspicious area in the as-laser-milled state. Even on the roughly milled surface a rectangular particle with a different appearance right underneath the first paint layer can be seen. Figure 5 further shows some redeposited material and other debris on the cross-section surface which make further analyses and interpretation of the suspicious findings difficult. However, as the laser-milling reveals a large sample area and allows for the suspicious area to be located, a necessary FIB post-polishing

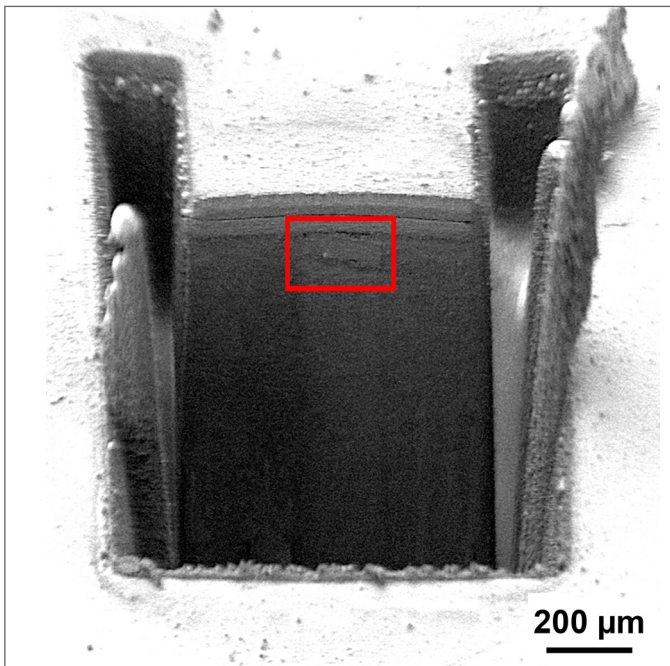
Figure 4: Laser-milled cross-section through surface defect, suspicious feature beneath paint layers visible; SEM, SESI, 50x.

With the help of the fs-laser a large trench of ca. 500 μm width and with a depth of > 500 μm was prepared. Figure 3 shows the overlay of the fs-laser trench on the exact position of the ROI marked in the light-microscopic investigation. In Figure 4 the cross-section of the failure area in the laser-milled state is shown. Next to the good surface quality of the cross-section and the steep side walls a suspicious area can be observed right underneath the several paint layers. To find out what the suspicious area is and if it might be the cause of the surface

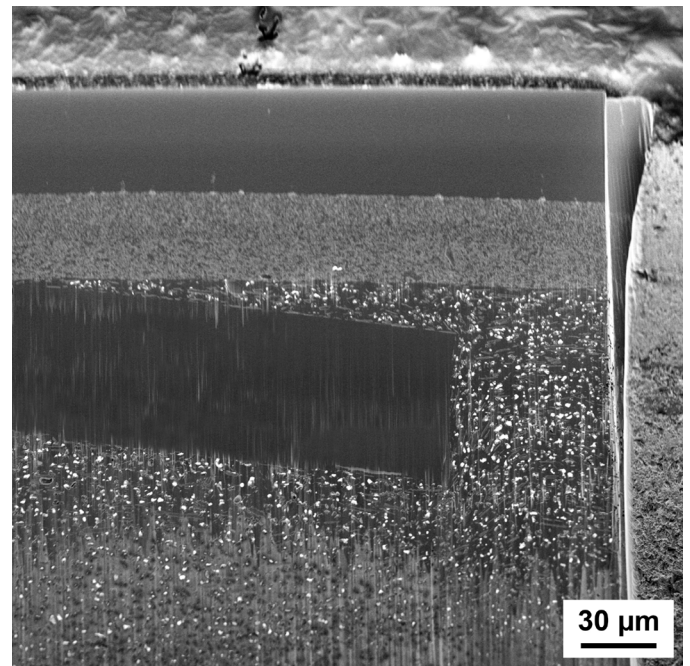
Figure 6: Suspicious feature after FIB post-polishing, good surface finish with clearly distinguishable features; SEM, InLens, 450x.

can be done much more precisely and with minimal effort. In case of the suspicious feature in figure 5 a relatively wide and deep FIB cut had to be done to fully reveal the feature but as a lot of material was already removed with the laser, the FIB post-polishing time did not exceed 2 hours. The results of the FIB post-polishing are presented in figure 6 and reveal an unstructured rectangular particle in the bumper base-material underneath the first paint layer with a large pore on the interface particle/substrate. Also, the different paint layers with their inner structure as well as the filler particles in the base material can be clearly distinguished in the FIB cross-section.

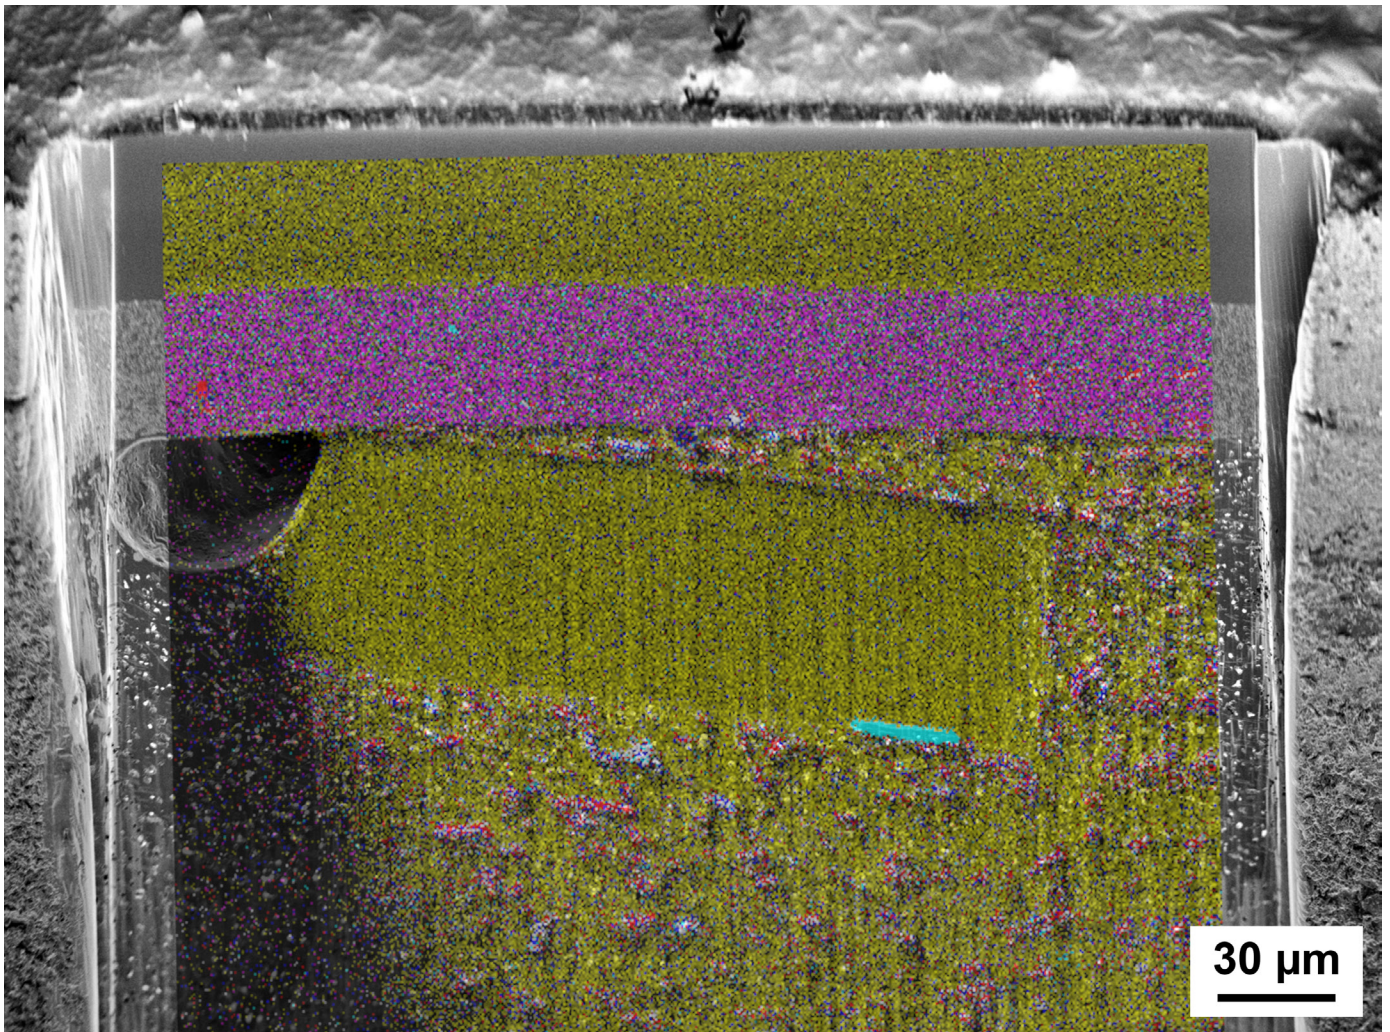
Figure 7: EDS element-mapping of FIB polished area, yellow: C intensity, blue: Al intensity, pink: Ti intensity, red: Si intensity.

Figure 7 shows the intensity map of C, Ti and Si over the whole cross-section. Further an Al signal can be detected on the lower end of the foreign particle. A denser coloration here means a higher intensity of one element and less intensity of the other. The structural similarity of the foreign particle with the top-coat of the sample and the high Al-content particle on the lower end indicate that the particle is residual clear lacquer with some small residual metallic lacquer additives which was not fully removed prior to the recycling step.

Based on these findings it can be assumed that the combination of humidity and temperature might result in a formation of pores at the interface between plastic and residual lacquer particle due to weak adhesion. The resulting volume change leads to the observed local buckling of the overlying layers.
