## **Concrete Crack Self-healing Materials Micro Structure Investigation**

Author: Tanvir Qureshi  
Department of Engineering University of Cambridge

Date: April 2016

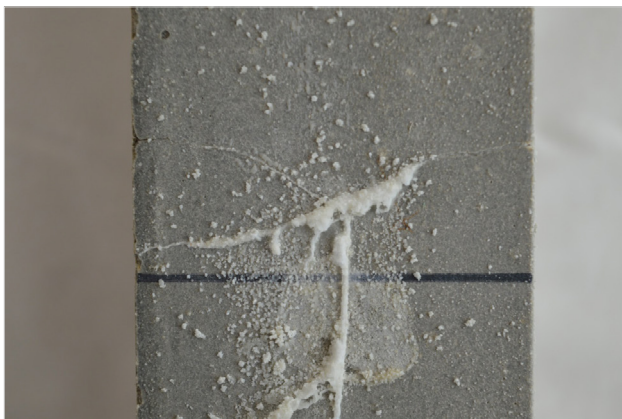
Figure 1 Self-healed sample
