Combined light-microscope – FIB/SEM failure analysis on automotive body parts

Technical Paper // Authors:

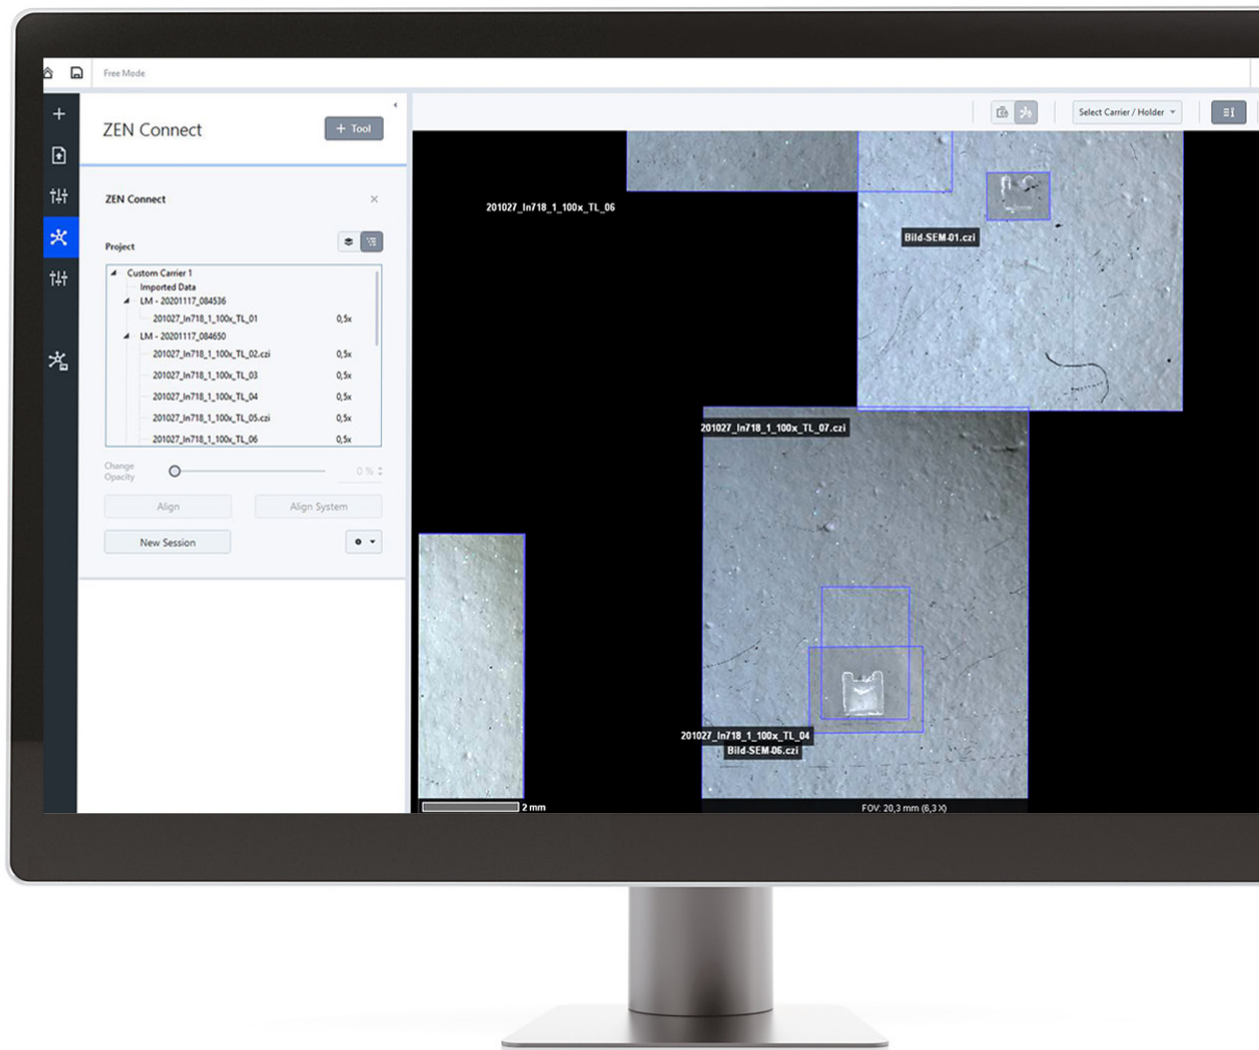
Figure 9: Overlay of laser-milled trench on lightmicroscope image of ROI; SEM, SESI, 450x.

With the help of fs-laser and FIB cross-section polishing and EDS analysis, the cause of the surface could then be determined as carbon fiber scraps. The correlative microscopy approach also makes it possible to time efficiently investigated more than one area of interest. All results are subsequently saved in a coherent project and are, thanks to the ZEISS ZEN data storage option, accessible for everyone in need for further investigation or reporting (Figure 9).
