# STEEL MUST LAST.

Combined ZEISS Microscopy for  
Quality Assurance in the Steel Industry.

## Quality Assurance in the Steel Industry.

SPC inspects materials with ZEISS microscopy.

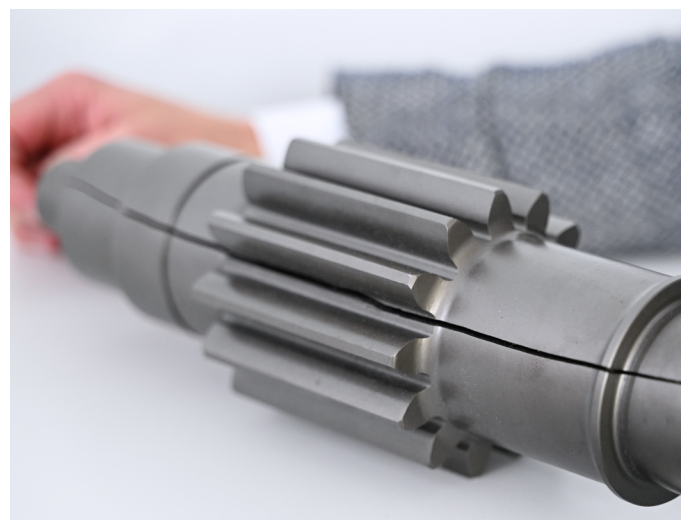
» *The analysis with the ZEISS Smartzoom 5 digital microscope shows: so-called 'scaling', i.e. oxidation of the steel, is visible around the central axis. So the fracture originated from the inside.*

a crack from the outside in." But the high-resolution analysis of a broken piece taken from a destroyed pinion shaft with the ZEISS SmaRTzoom 5 digital microscope suggests a different conclusion: "Even with the naked eye, we could see from the sample taken that the steel on the center axle is heavily darkened on the inside, which decreases towards the outside," says Thomas Schaupp. "And the microscopic analysis shows: around the central axis, a so-called 'scaling', i.e. oxidation of the steel, is visible. So the fracture originated from the inside."

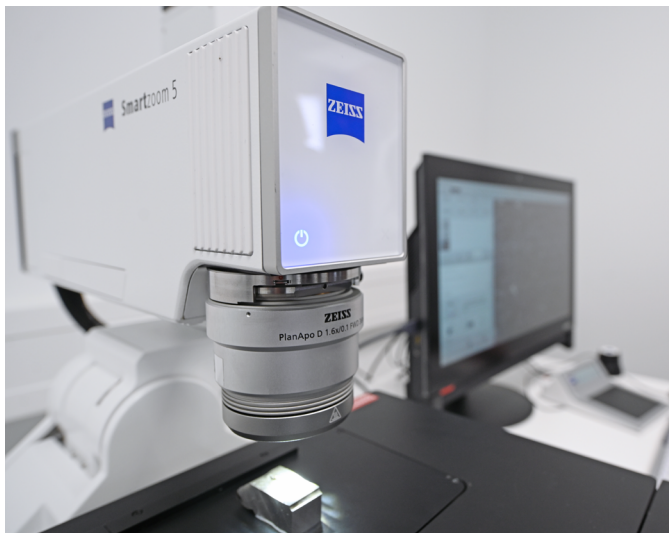
Magnification of the fracture surface with the digital microscope ZEISS Smartzoom 5.

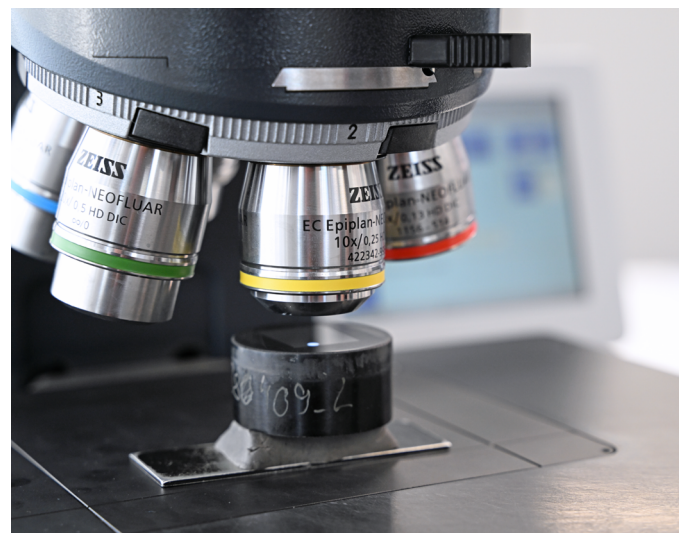
In order to analyze the microstructure inside even more precisely, a metallographic section is produced.

To analyze the structure inside even more precisely, SPC staff created another sample, a metallographic section embedded in black epoxy resin, polished smooth and treated on the surface with an acid. "The etching process causes a chemical reaction

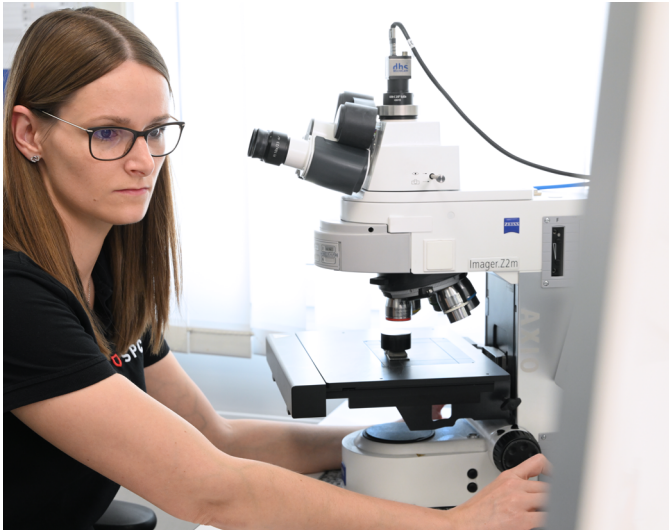
*The sample is examined using the ZEISS Axio Imager, a high-resolution wide-field microscope for automated materials research.*

For this purpose, the SPC staff examined the sample with ZEISS Axio Imager, a high-resolution wide-field microscope for automated materials research. Thomas Schaupp reports:

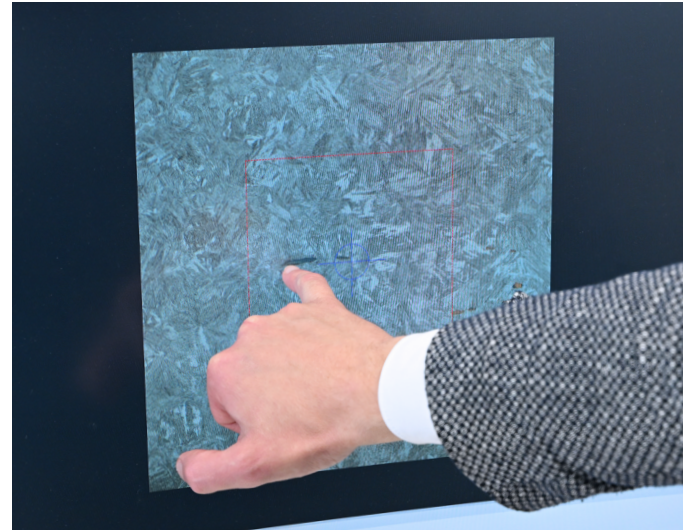
*The analysis confirms contamination on the central axis; non-metallic inclusions from foreign material are also detected.*

» *"The analysis confirmed that 'segregation' had taken place near the central axis, i.e. contamination; in addition, we saw non-metallic inclusions. This caused the steel to become brittle."*

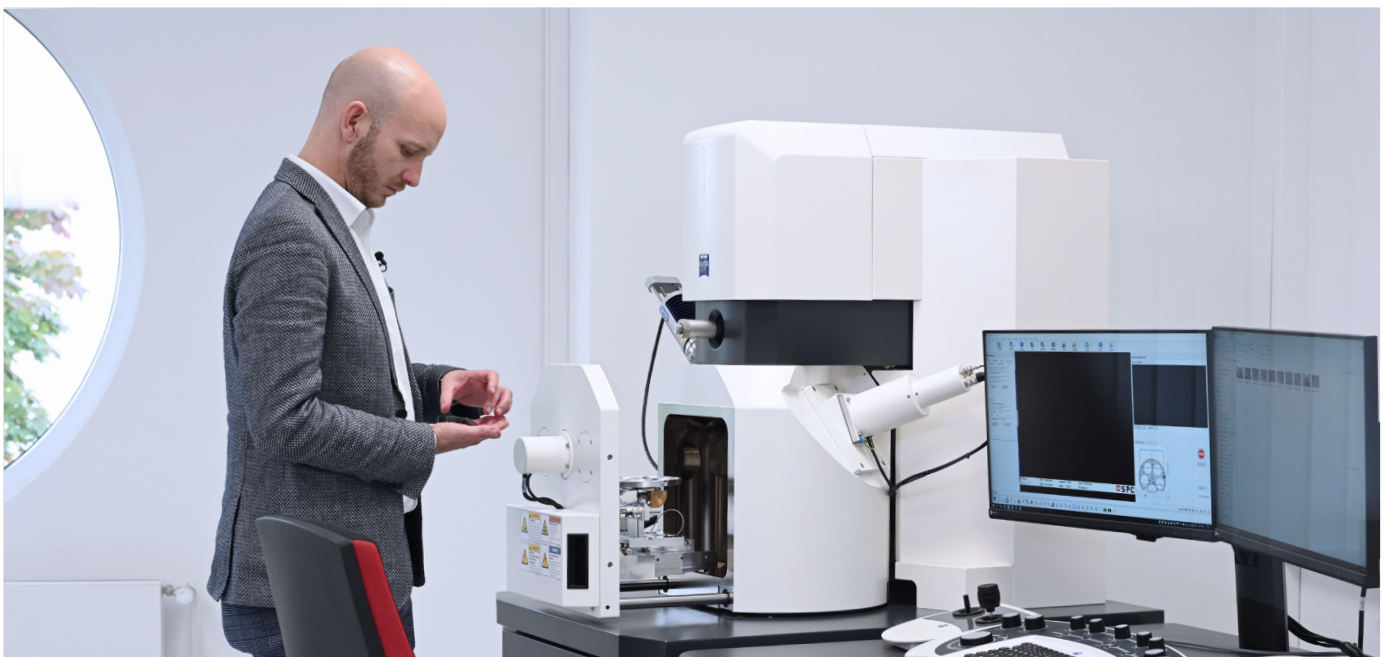
*The final step was to identify which materials the contamination consisted of. To do this the employee examined a metallographic section of the pinion shaft using the ZEISS EVO scanning electron microscope.*

The final step was to identify what materials the contamination consisted of. To do this, the staff examined a metallographic section from the pinion shaft using the ZEISS EVO scanning electron microscope, whose additional energy dispersive spectroscopy (EDX) capability allows them to perform a chemical material analysis in which an electron beam excites the atoms in the sample and the resulting X-rays are measured. The analysis shows: In the steel of the pinion shaft, there were non-metallic inclusions with high concentrations of manganese and sulfur near the central axle, as well as segregations of sulfur and phosphorus. Thomas Schaupp explains: "Normally, these impurities would still be tolerable, but a hole was drilled at
