Microscopy in Metal Failure Investigations

Author: Dr. Roger Barnett
Carl Zeiss Microscopy, Cambridge UK

Date: September 2018

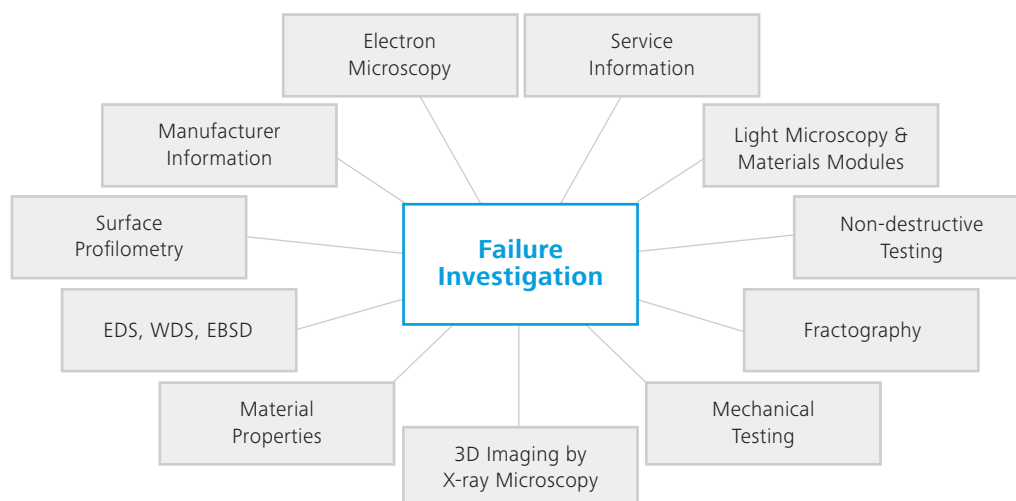
Figure 1 Investigative techniques for failure investigation

- Mechanical testing and/or simulated service condition testing.
- Analysis of all gathered information, then drawing conclusions based on evidence. This is illustrated in Figure 1.

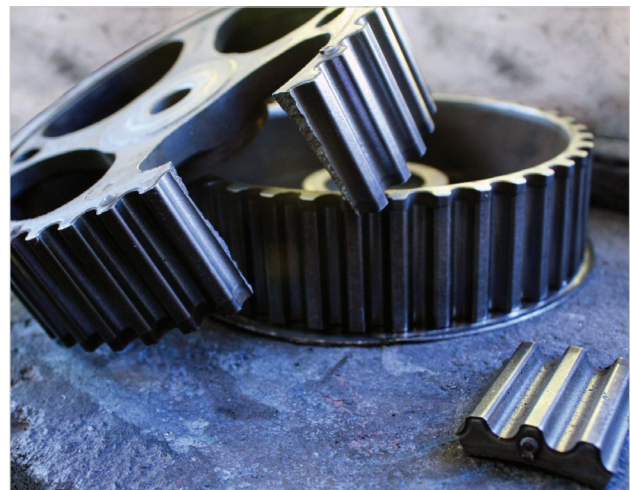
Figure 3 Example of failed component: cracked gear from an engine timing component.

Taking steel as an example, a failure may occur at almost any point after the steel has solidified – during casting, rolling, drawing, welding, coating and subsequent manufacturing steps, or while in service. Figure 3 shows an example of metal failure. Failure modes fall into several broad categories though complex failures may occur by sequential or parallel occurrences of two or more different fracture types that display characteristic fracture surfaces.
